Inspection reference: Sample

Confidential Inspection Report
123 Your Place
Anytown Wa. 98999

March 23, 2016

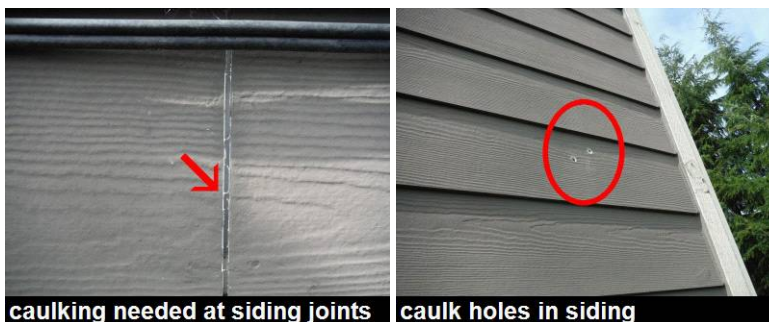
Typical caulking maintenance is recommended at the siding joints and screw/nail holes East in order to prevent moisture damage to the underlying wall surfaces.

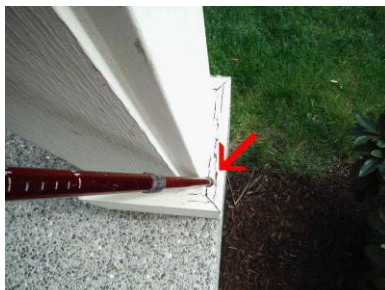
Cracked caulking was observed at the exterior trim areas, suggest re-caulking these areas to prevent water penetration.

paint/caulk needed front column trim

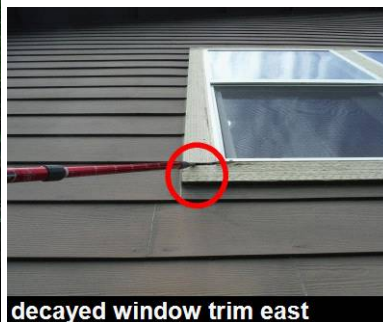
Areas of the window trim were rotted East. This may allow water damage to the underlying surfaces and can encourage wood destroying insect infestation. Correction by a qualified contractor is recommended.

decayed window trim east

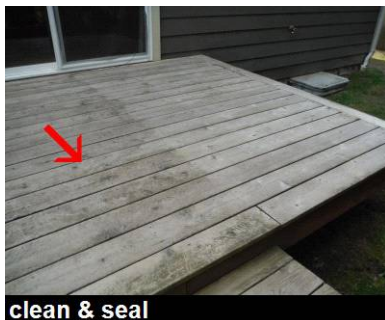
Wood, The wood surfaces on the deck would benefit from cleaning and applying a water sealer to protect and extend the life of the materials.

clean & seal

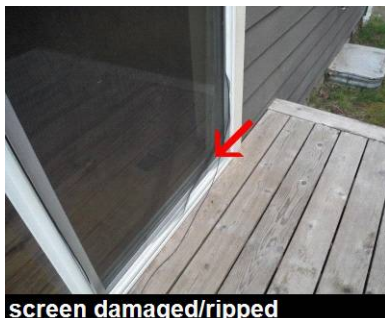
The screens were torn or damaged at the rear exterior slider. Repair or replacement is recommended to help prevent flying insects from entering the house.

screen damaged/ripped

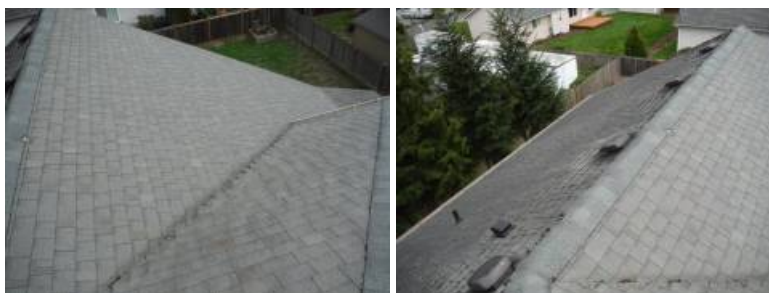
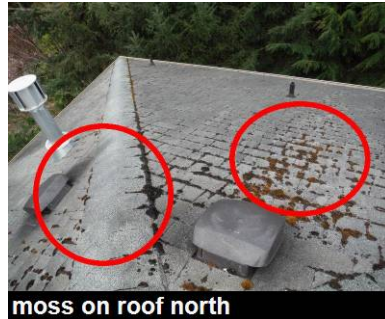
Asphalt Shingles, Moss and debris were noted on the roof shingles. This indicates that the roof is no longer properly shedding water and is remaining wet. Suggest cleaning the roof valleys, treating the roof for moss, and after the moss dies removing the dead moss. We do not recommend the use of power washers!

moss on roof north

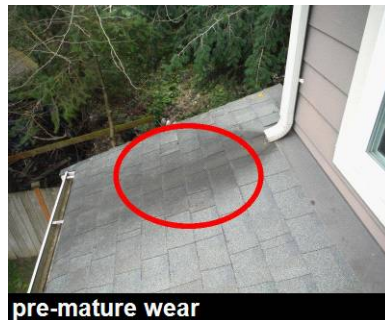
The upper level downspouts are draining on the lower level roof, causing wear of the granular shingle covering. suggest installing downspout extensions to the lower level gutters, to prevent premature wear of the shingles.

pre-mature wear

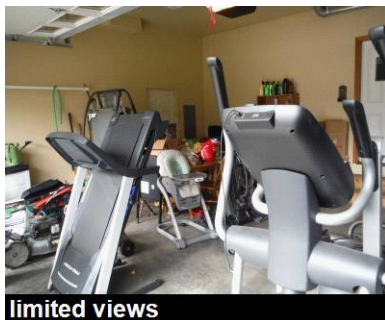
limited view: Portions of the Garage walls and floors were not inspected due to stored personal items blocking access. Stains or defects may be hidden behind these items and are excluded from this inspection. Recommend a careful review of these areas after the stored items have been removed.

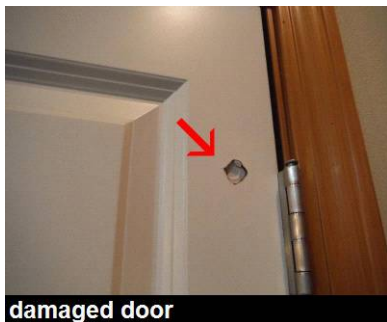
D. Doors The pantry interior door was damaged (split or holes). Repair or replacement is recommended.

damaged door

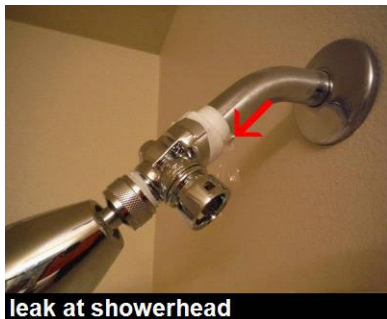
The shower head is leaking in the 2nd floor shared bathroom when the water is turned on . This could allow water infiltration into the wall cavity. Proper correction is recommended.

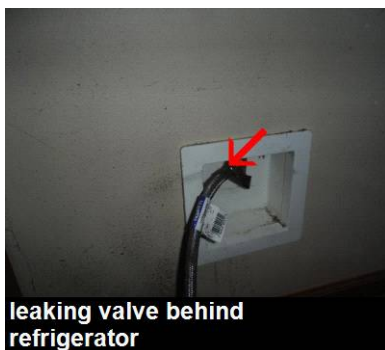
Appliance 2 Refrigerator- The water valve servicing the refrigerator dispenser/icemaker appeared to be leaking when engaged. recommend further review and repair by a qualified contractor. (valve returned to close position after testing)

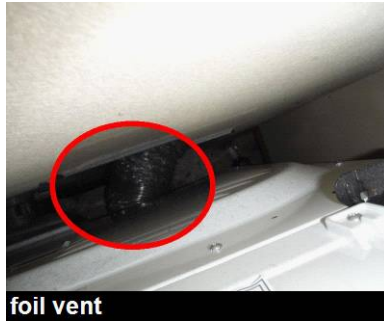
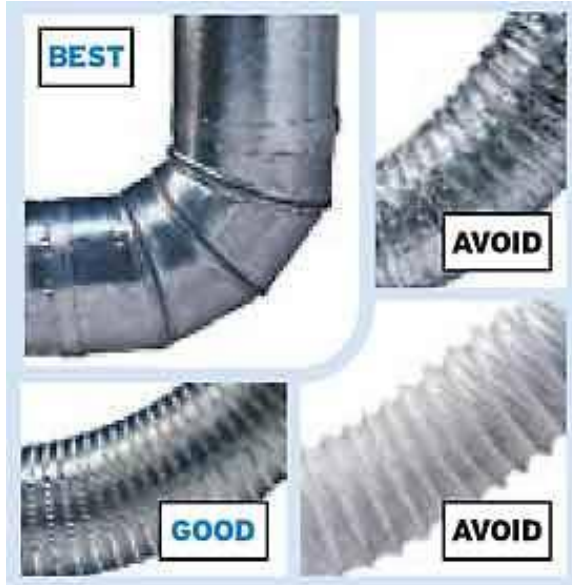
Appliance 6 Dryer- The clothes dryer vent was of a plastic or foil material that may be a fire hazard. Recommend replacement of the vent material with a proper type by a qualified appliance technician.

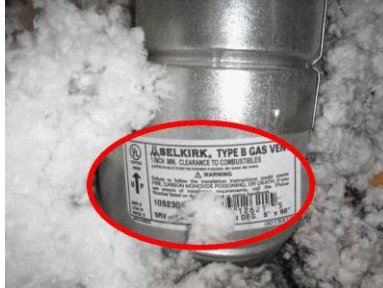
The flue is in contact with insulation in the attic. 1" clearance for B vents are needed for safety. Proper correction by a qualified heating contractor is recommended.

poor clearance furnace flue in attic

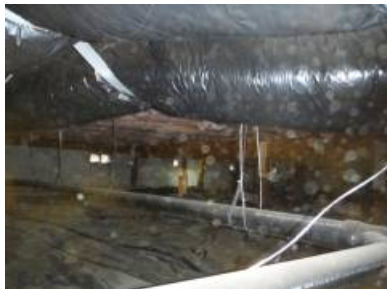
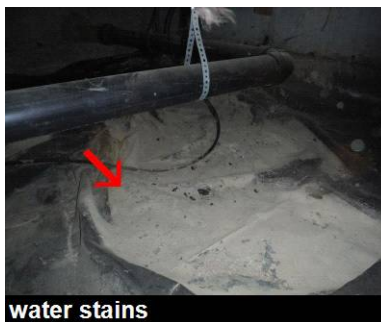
Staining (apparently from moisture) was observed on the crawl space floor. The staining was DRY. Often this indicates that water may pool on the crawl space floor during seasonal rain conditions. Recommend monitoring the crawl space for standing water during heavy rain conditions.

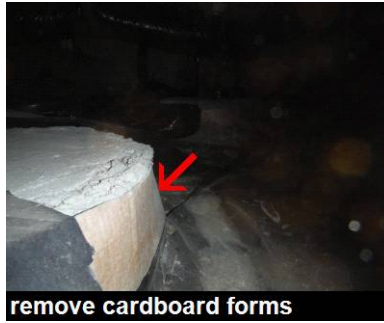
The concrete footings still have the cardboard forms attached to them, this is a conducive condition, and can attract wood destroying organisms. recommend removal by a qualified contractor.

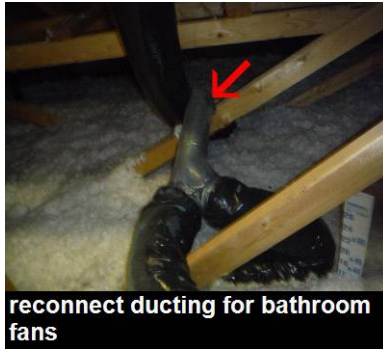
The bathroom exhaust fan(s) appeared to vent into the attic space. This can trap

excessive moisture in the attic space and can promote rotting and mold. Recommend all exhaust fans be ducted directly to the exterior.
