Inspection reference: Sample

Confidential Inspection Report
123 Your Place
Anytown Wa. 98999

March 23, 2016

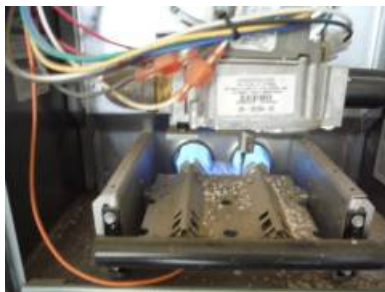
Weather King.

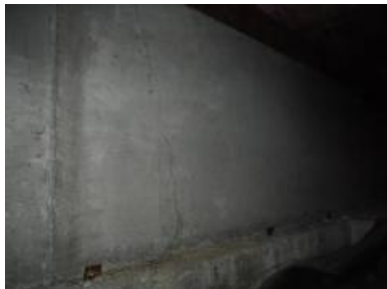
G. Foundation Walls

The concrete footings still have the cardboard forms attached to them, this is a conducive condition, and can attract wood destroying organisms. recommend removal by a qualified contractor.

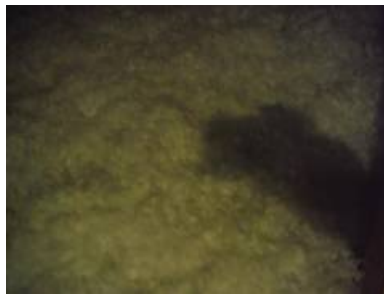
B. Insulation

The flue is in contact with insulation in the attic. 1" clearance for B vents are needed for safety. Proper correction by a qualified heating contractor is recommended.

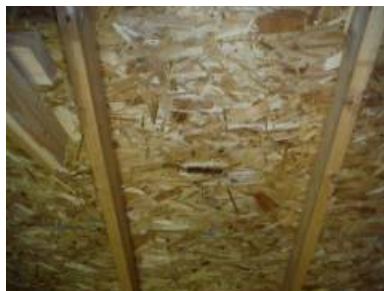
D. Roof Sheathing

The bathroom exhaust fan(s) appeared to vent into the attic space. This can trap
